ITI Agreement Ref: ITI-2020-DRZ-0024  
GIS Order No.: ITI-2020-0355-TJ

## INSPECTION REPORT

**APPLICANT:** HONGKONG BRISK COMPANY LIMITED

**COMMODITY DESCRIPTION:** PIPE

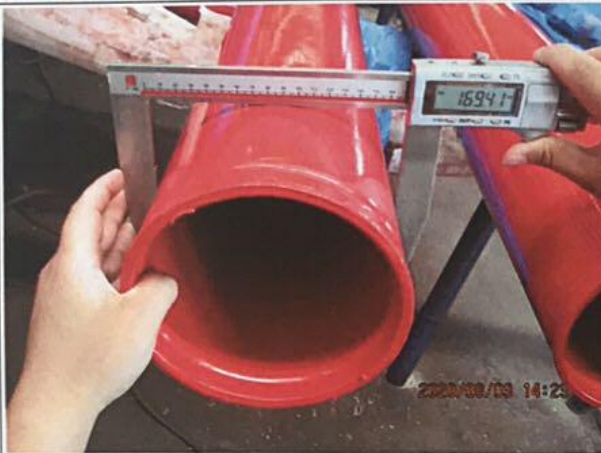
Pic.13 Outside diameter check

Inspector randomly selected 2 pcs product to measure the wall thickness, outside diameter, length, actual data as below:

Product Name	Size(mm)(declared)	Size(mm)(actual)
PIPE	168.3 x 7.11 x 5800mm	169.41 x 6.88 x 5812mm
		169.02 x 6.78 x 5801mm

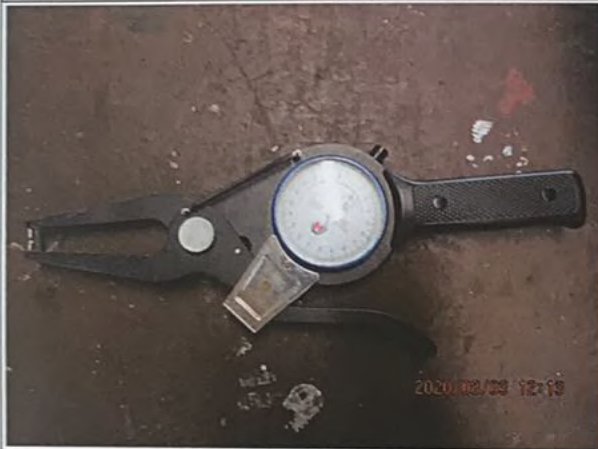
Pic.19 Measuring appliance

No.	Name	Measuring rang	ID NO	Calibrated (YES/NO)
1	Steel Tape*	/	GC19	NO
2	Electronic Digital Calipers*	300MM	1623	NO
3	Micrometer*	0-20MM	2020879	NO
4	Ultrasonic Thickness Meter*	/	1690	NO
